9 Option Improvement

9.1 Option 4A: North Arm Splay Widening for Freight (Wet Dock) – South Arm for Passengers

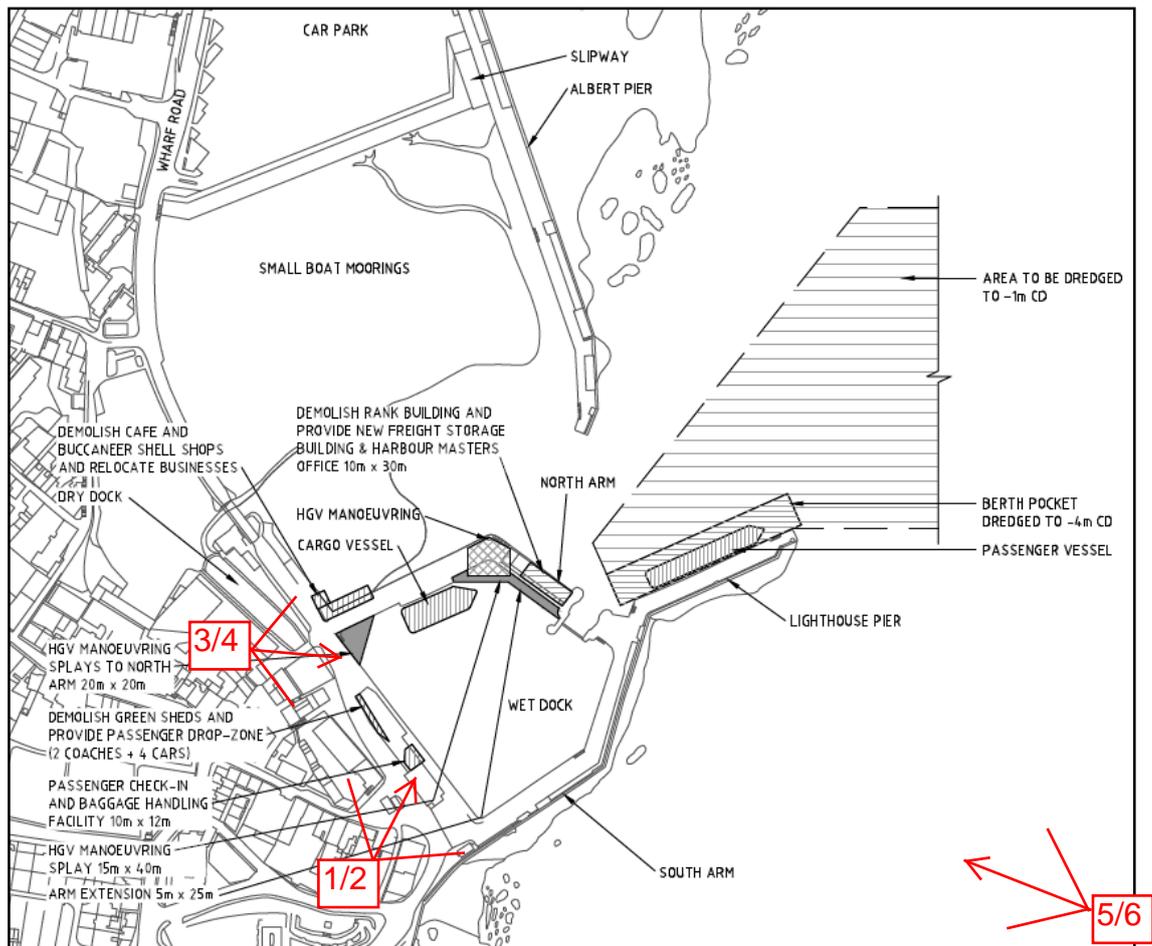
Option 4A seeks to avoid the adverse impact that the option 4 passenger facilities would have had by removing the covered walkway and placing the check-in and baggage handling facilities adjacent to Quay Road. This can only be achieved by demolition of the “Green Sheds” which will mean the relocation of Penwith Marine Services and relocation of the storage facilities for the Penzance Dry Dock. Advantage can be taken of their removal by reuse of the remaining area for limited coach (max 2no.) and car passenger drop-off facilities (max. 4no.).

Option 4A seeks to rectify the above by demolishing the Rank Building and replacing it with a purpose-built freight storage building at the end of the North Arm. The new building would also need to accommodate the Harbour Master's Office, workshop and stores (currently located at the southern end of the Rank Building). The existing Rank Building is in a poor state of repair and is not well used for storage since it was not built for the purpose and, consequently, has a poor layout. The Rank Building has a raised ground floor and a first floor which projects over the quay so as to prevent high-sided vehicles from accessing the west side. It is also a visual intrusion into a Conservation Area and is not well liked.

Accessibility to the east side of the new building would be improved by a 5m extension to the quay which would project into the wet dock. Both accessibility and HGV manoeuvring would also be improved by a decked splay in the north-east corner of the wet dock which would allow an HGV turning-circle and direct access to the extension.

Direct HGV access to the North Arm would be improved by demolition of the Café and Buccaneer Shell shop. There is an existing curved splay under the buildings which could serve to allow direct access without the need for construction of a decked splay to the north corner of the root.

HGV access to and from the south of the North Arm would be improved by a decked splay across the southern corner of the root.
